**SUNFLOWER ELECTRIC
POWER CORPORATION**

ANNUAL LANDFILL INSPECTION REPORT

**Sunflower Electric Power Corporation
Holcomb Station Unit #1
2440 Holcomb Lane / P.O. Box 430
Holcomb, KS 67851**

January 13, 2017

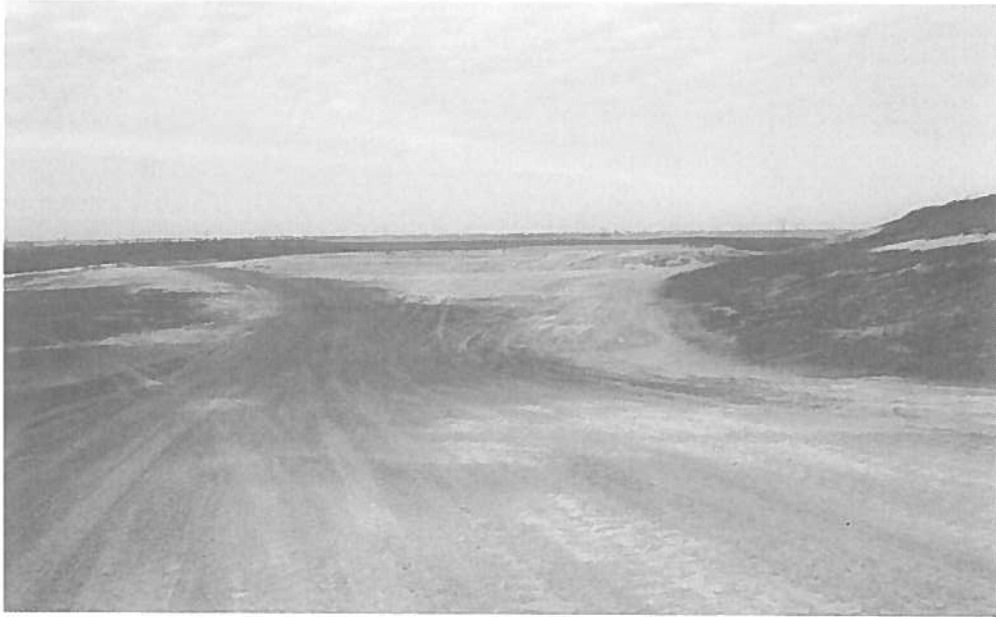
Photo 1: Entrance road to Phase 3A

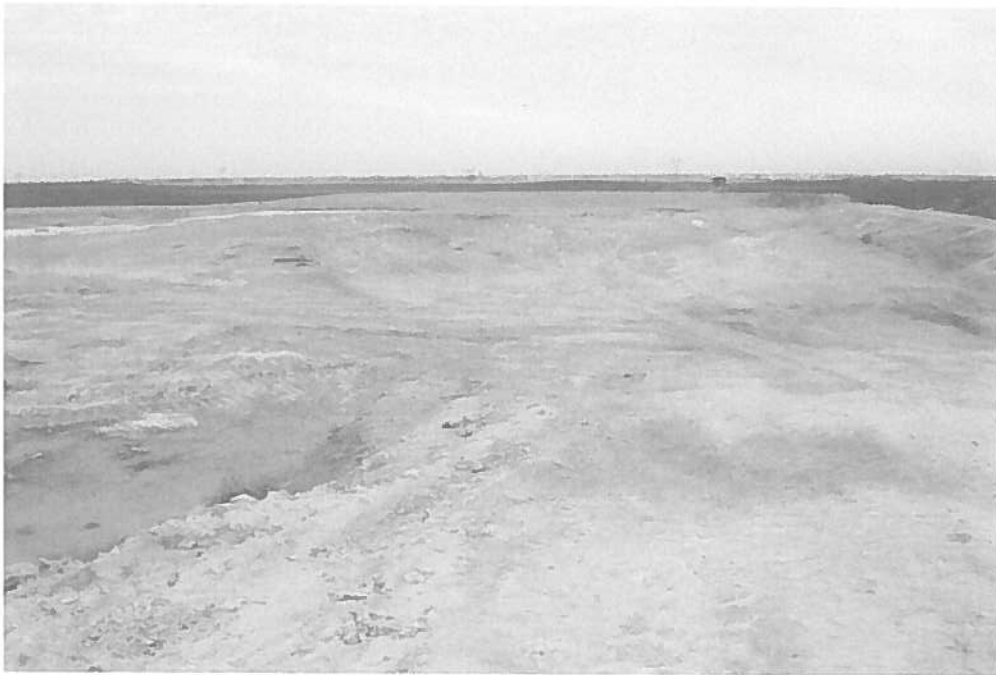
Photo 2: Phase 3A looking east

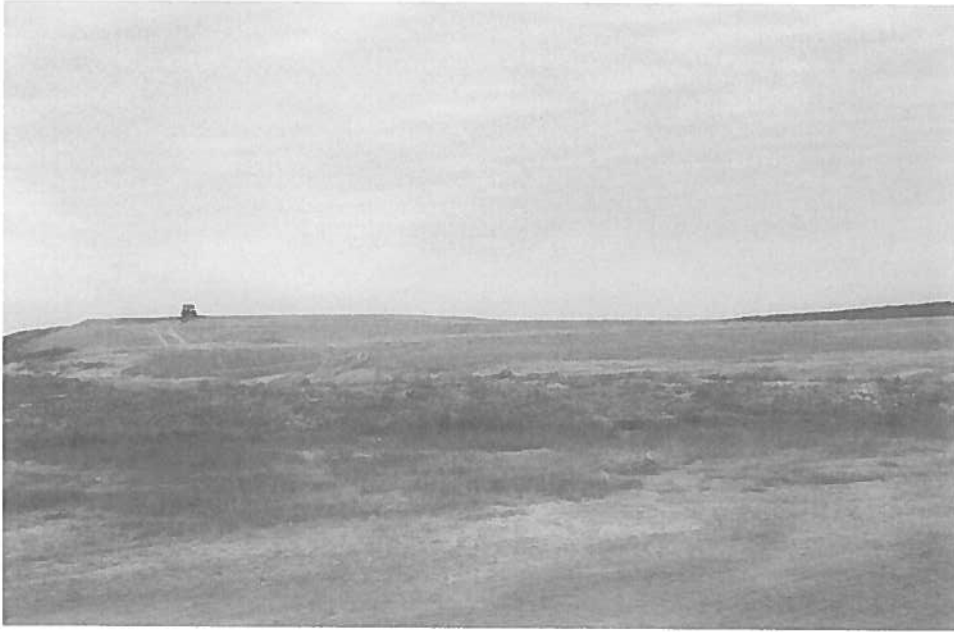
Photo 3: East side of Phase 3A looking west

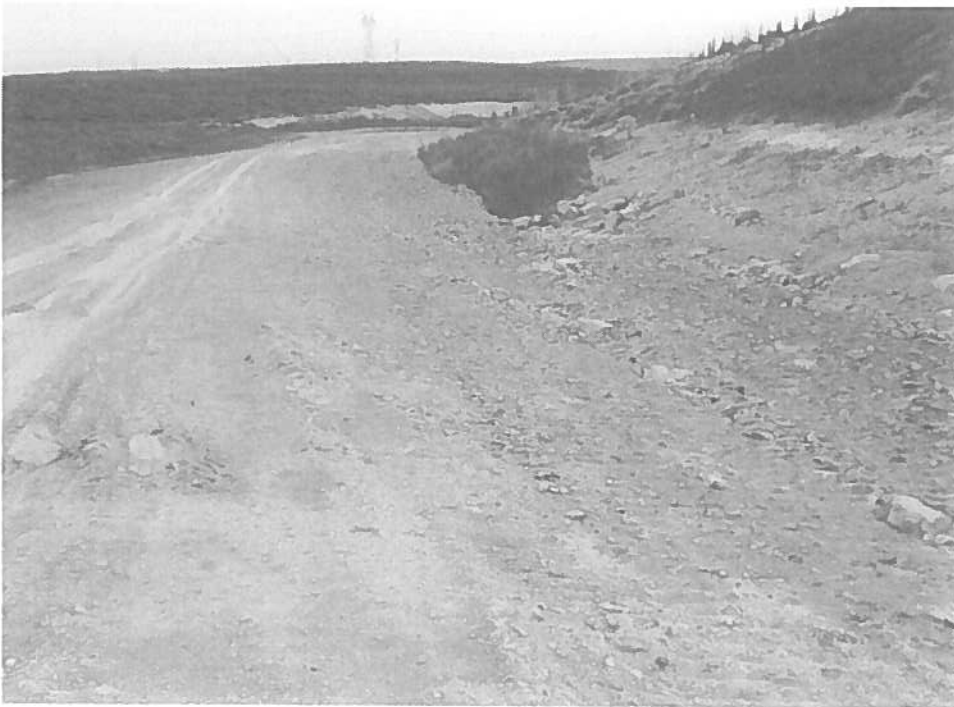
Photo 4: East side of Phase 3A looking east

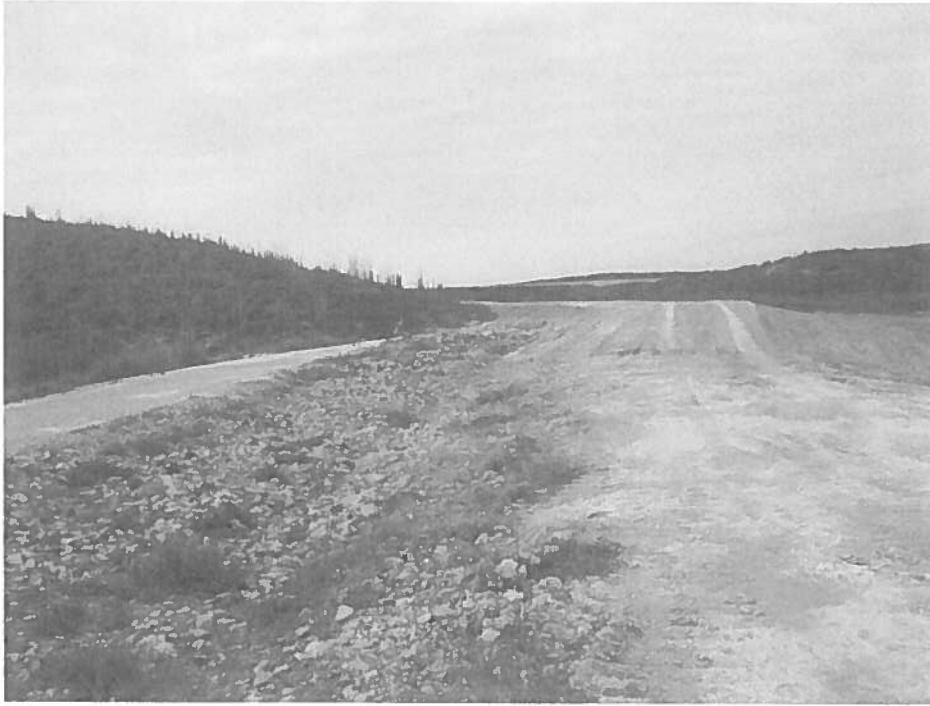
This is the second annual inspection conducted under the CCR rules for the Holcomb Landfill. There were no activities on the landfill at the time of the inspection. The landfill has had 42,455 tons of CCR placed in the landfill since the last inspection. The significant rainfall that occurred during the summer months resulted in significant water flow through the contact water ditch causing erosion and displaced rip-rap as noted in the weekly inspection reports. Additional repairs to the contact water ditch is scheduled in 2017 after the scheduled maintenance outage in the spring.

Photo 5: East end of contact water ditch for Landfill looking west

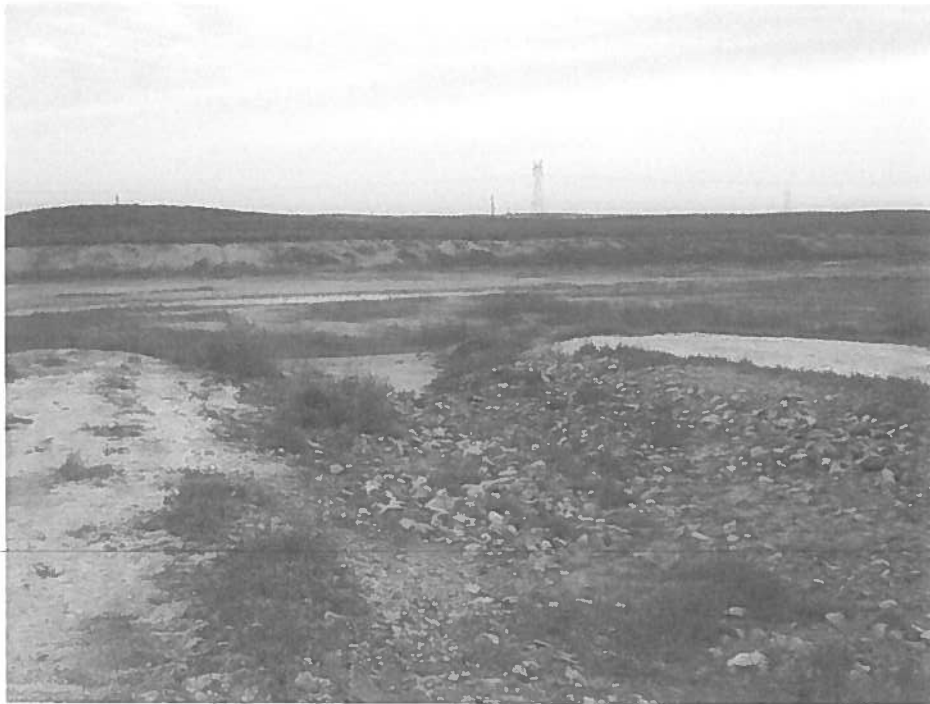
Photo 6: East end of contact water ditch to evaporation basin

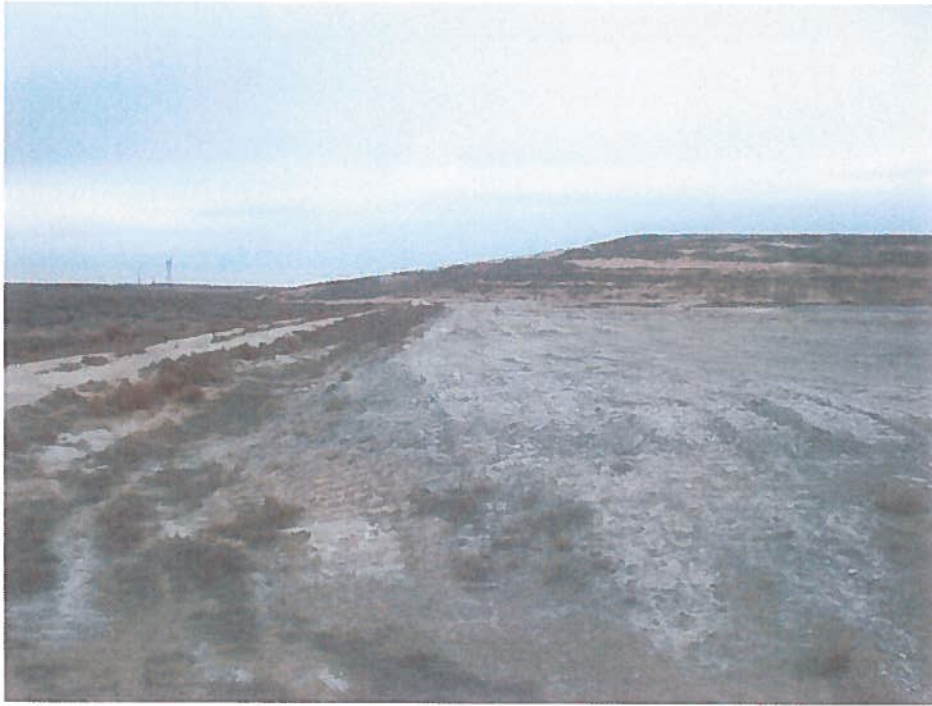
Photo 7: Access road around Phase 3A

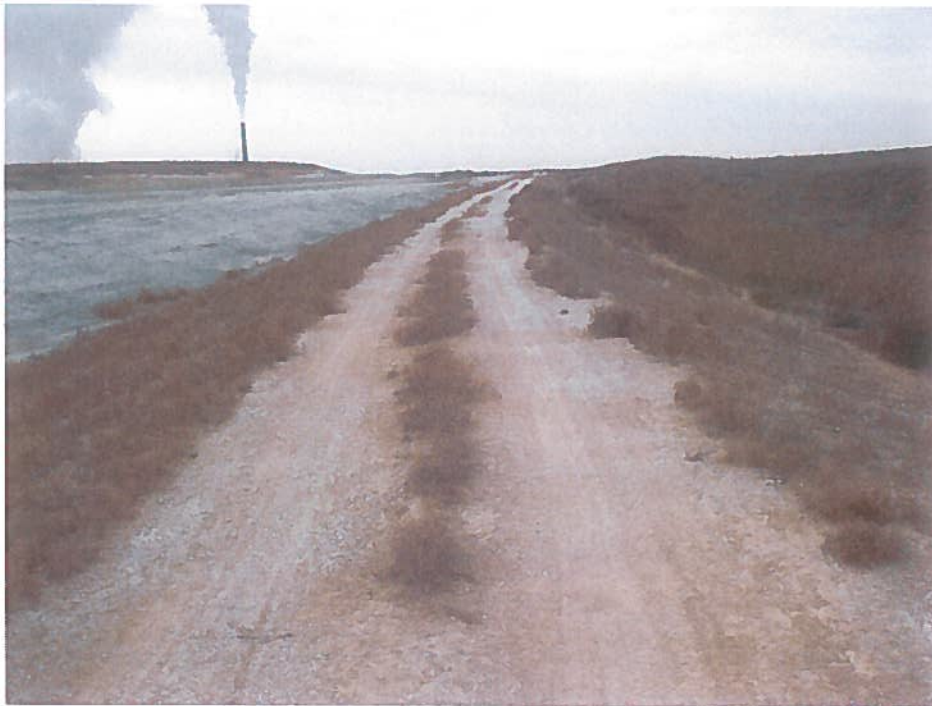
Photo 8: Looking south from access road around Phase 3A
