**SUNFLOWER ELECTRIC  
POWER CORPORATION**

# **ANNUAL LANDFILL INSPECTION REPORT**

**Sunflower Electric Power Corporation  
Holcomb Station Unit #1  
2440 Holcomb Lane / P.O. Box 430  
Holcomb, KS 67851**

January 9, 2018

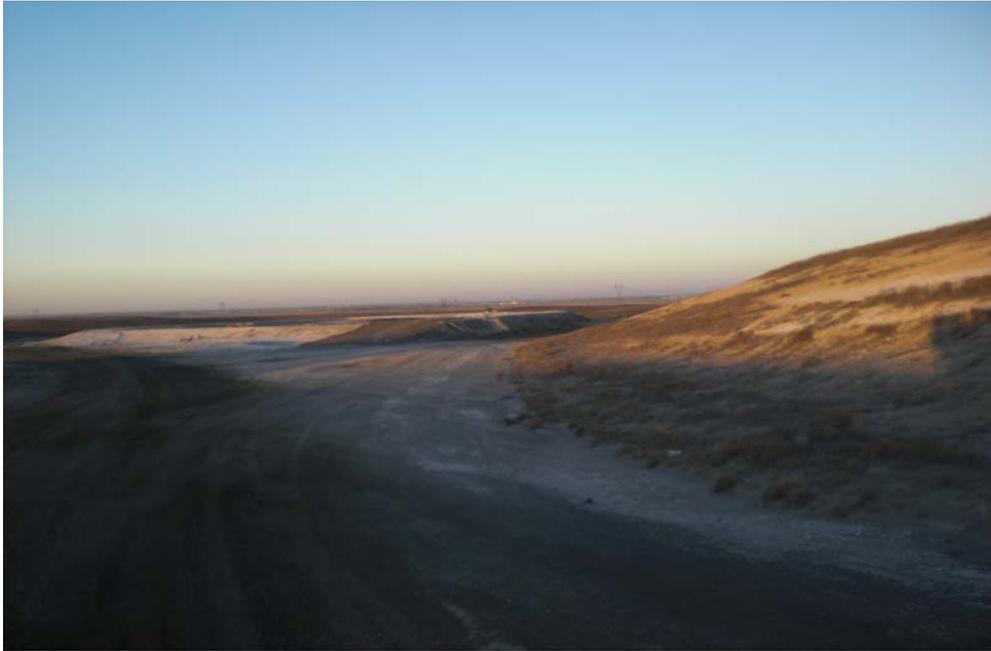
Photo 1: Entrance road to Phase 3A

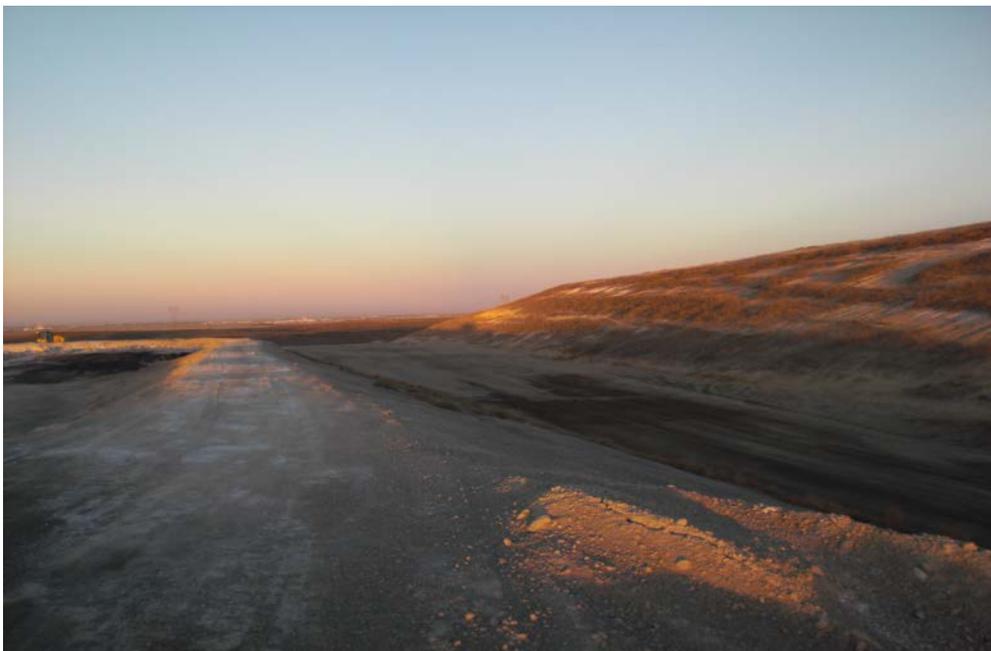
Photo 2: Phase 3A looking east. On top of waste pit.

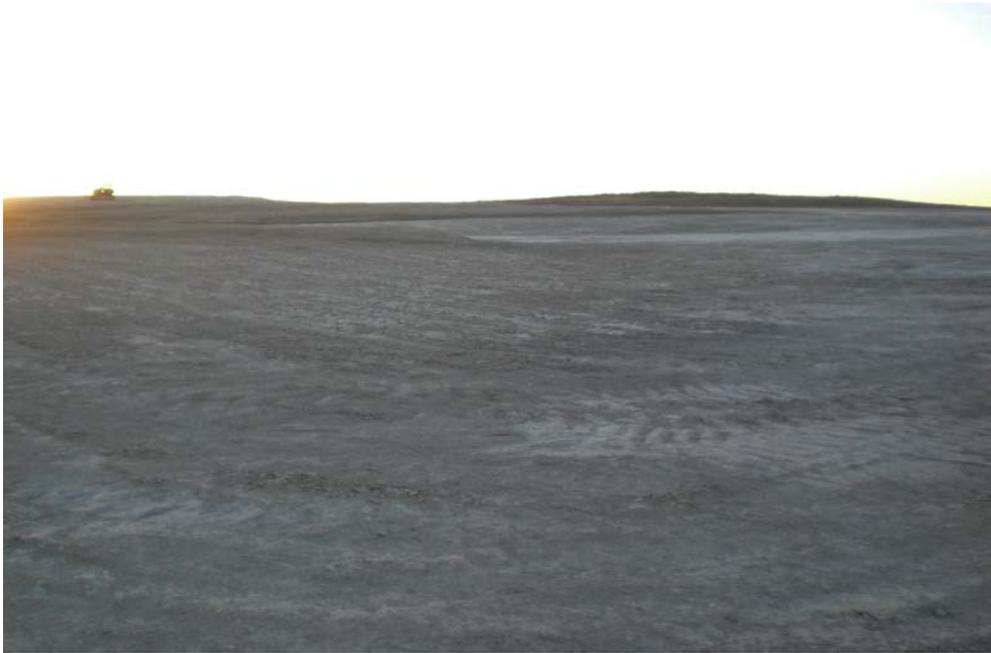
Photo 3: East side of Phase 3A looking west

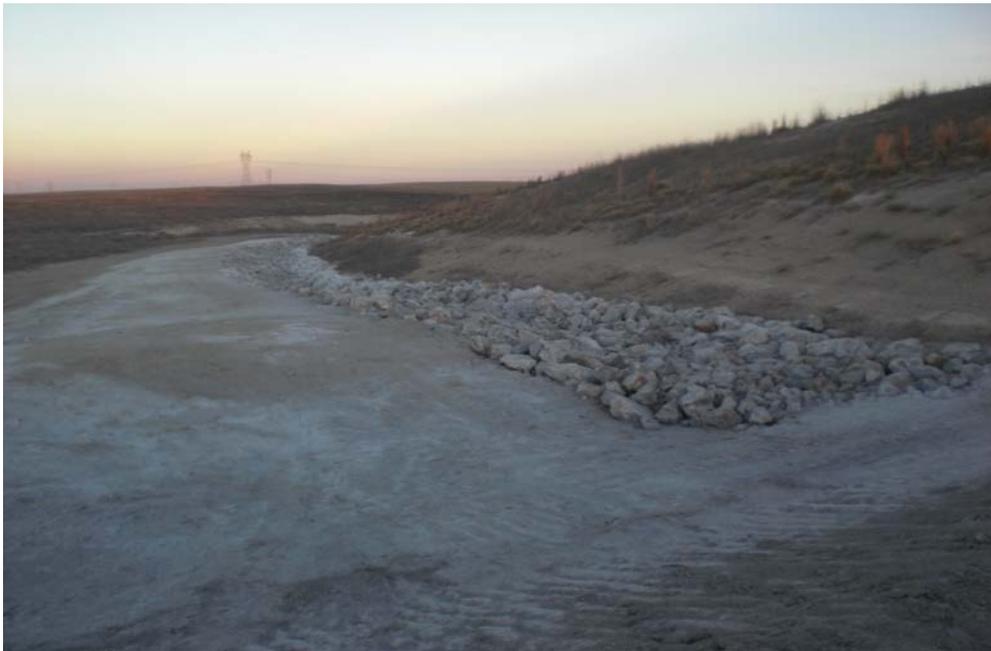
Photo 4: East side of Phase 3A looking east at contact water ditch

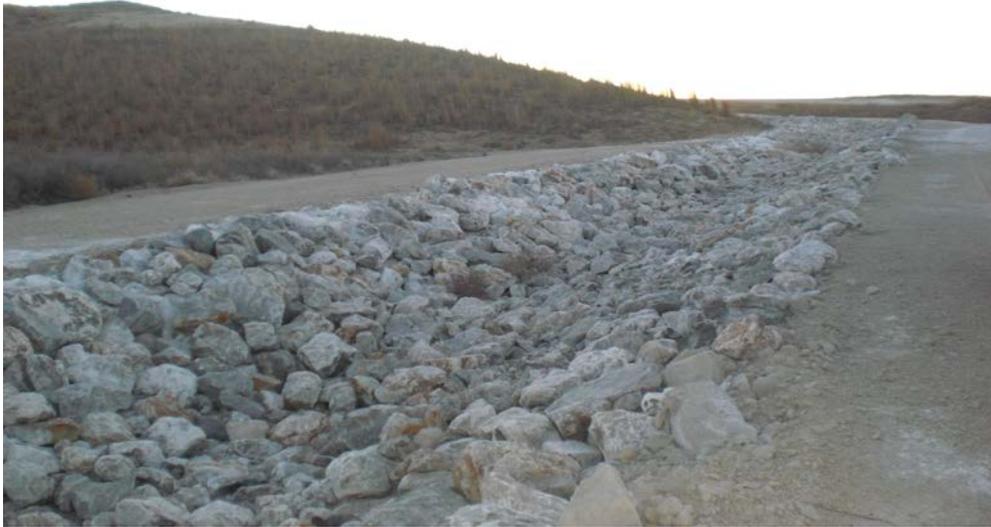
Photo 5: East end of contact water ditch for Landfill looking west

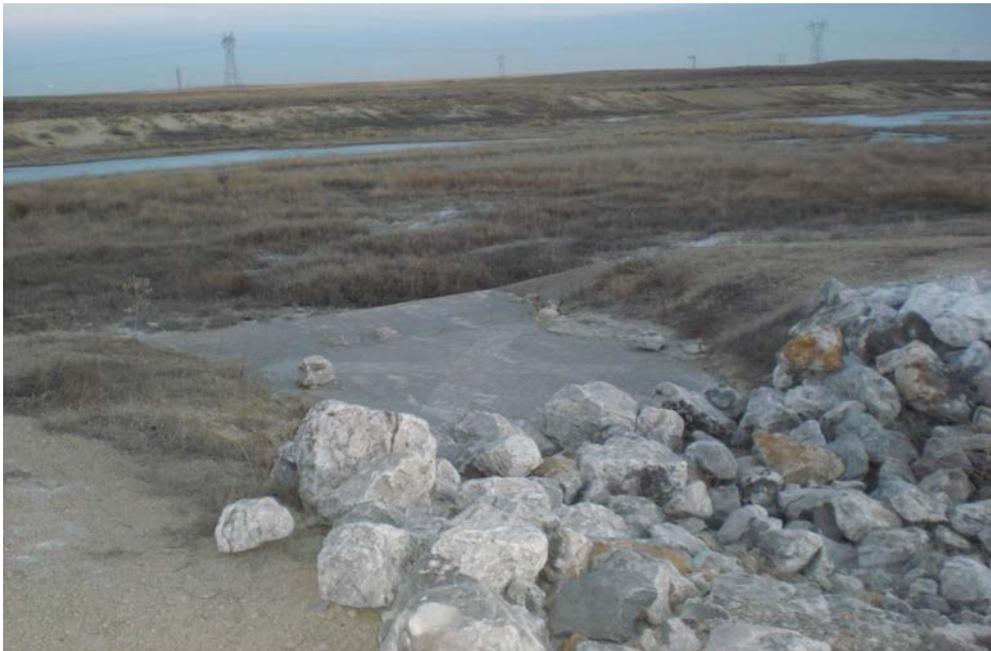
Photo 6: East end of contact water ditch to evaporation basin

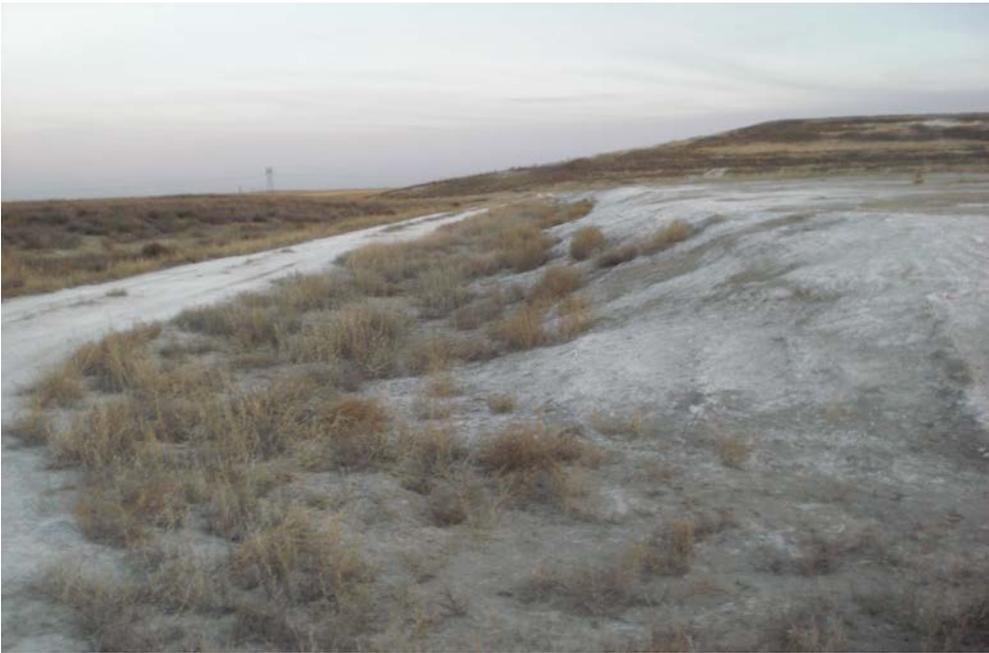
Photo 7: Access road around Phase 3A

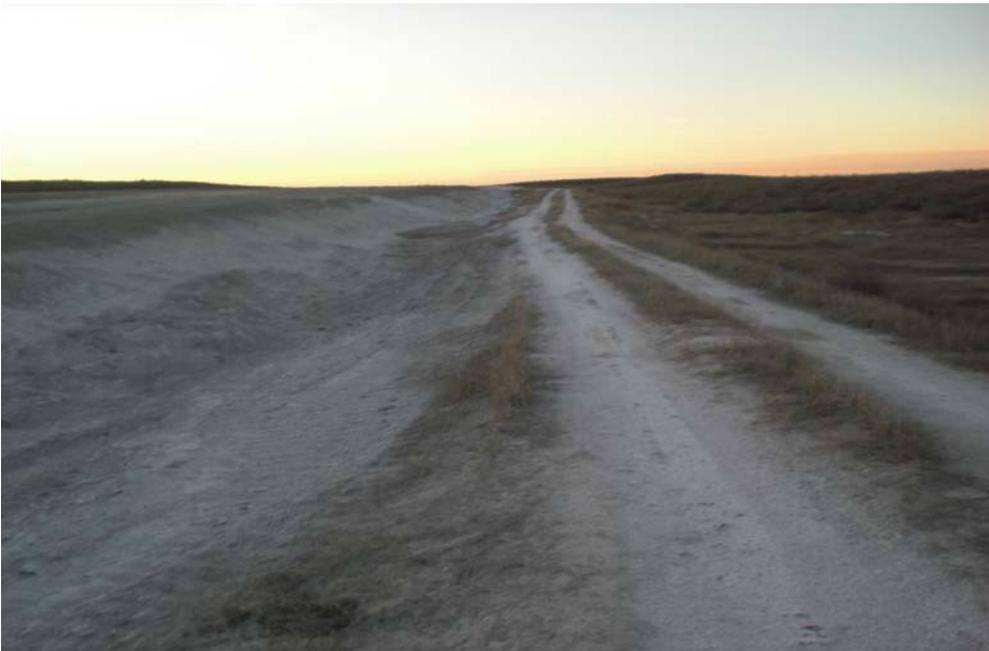
Photo 8: Looking south from access road around Phase 3A
