**SUNFLOWER ELECTRIC
POWER CORPORATION**

ANNUAL LANDFILL INSPECTION REPORT

**Sunflower Electric Power Corporation
Holcomb Station Unit #1
2440 Holcomb Lane / P.O. Box 430
Holcomb, KS 67851**

January 7, 2019

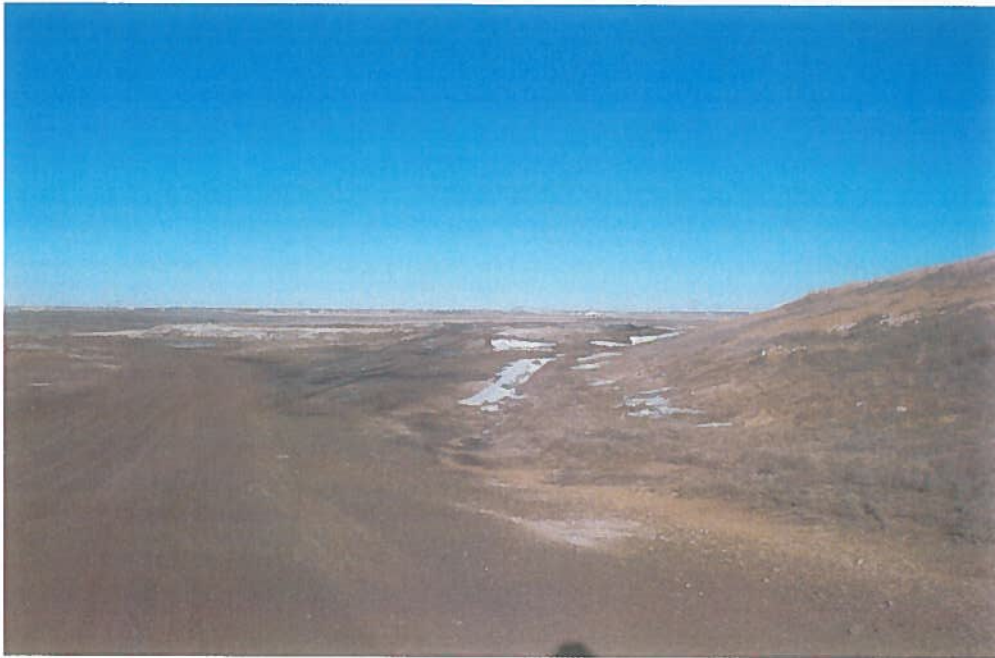
Photo 1: Entrance road to Phase 3A

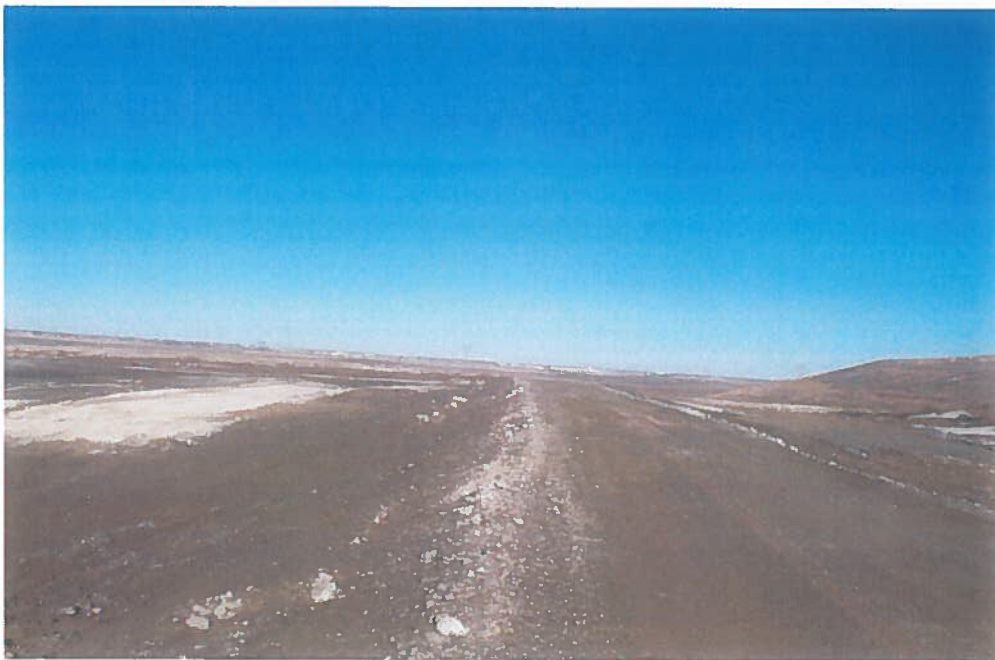
Photo 2: Phase 3A looking east. On top of waste pit.

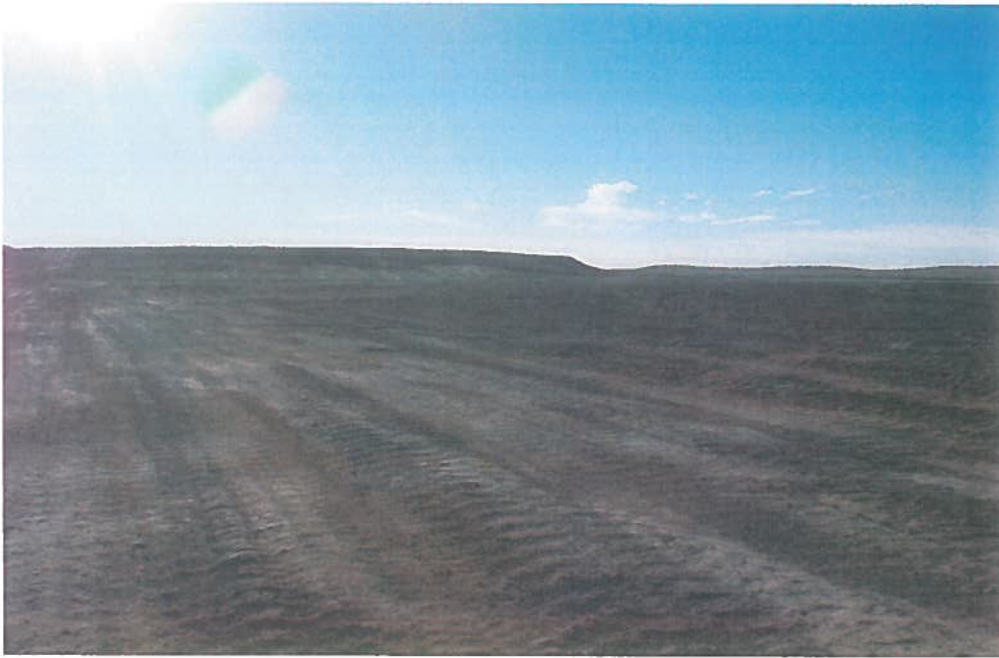
Photo 3: East side of Phase 3A looking west

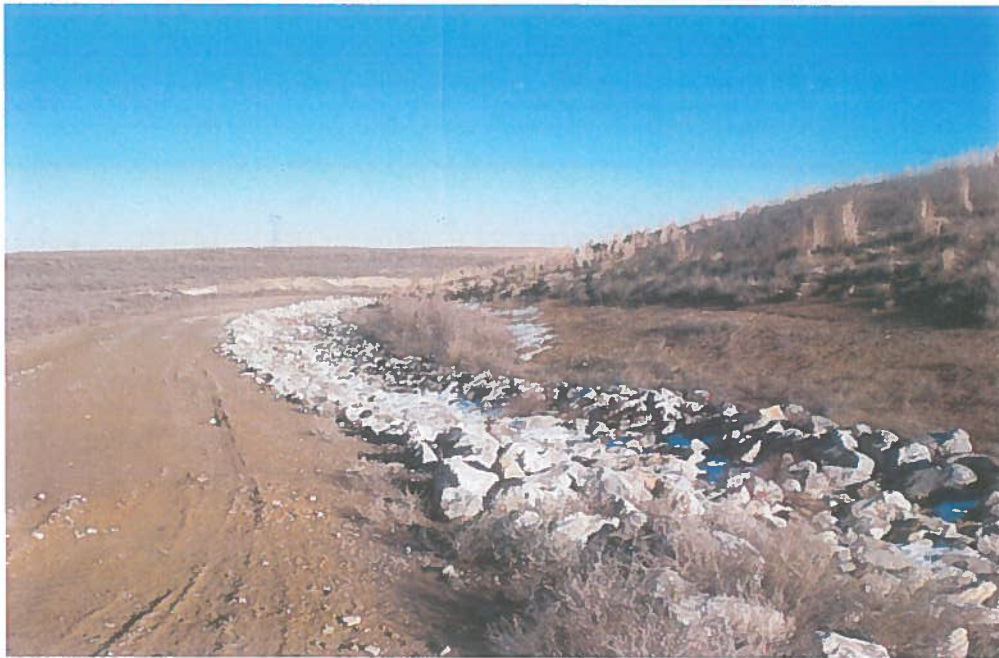
Photo 4: East side of Phase 3A looking east at contact water ditch

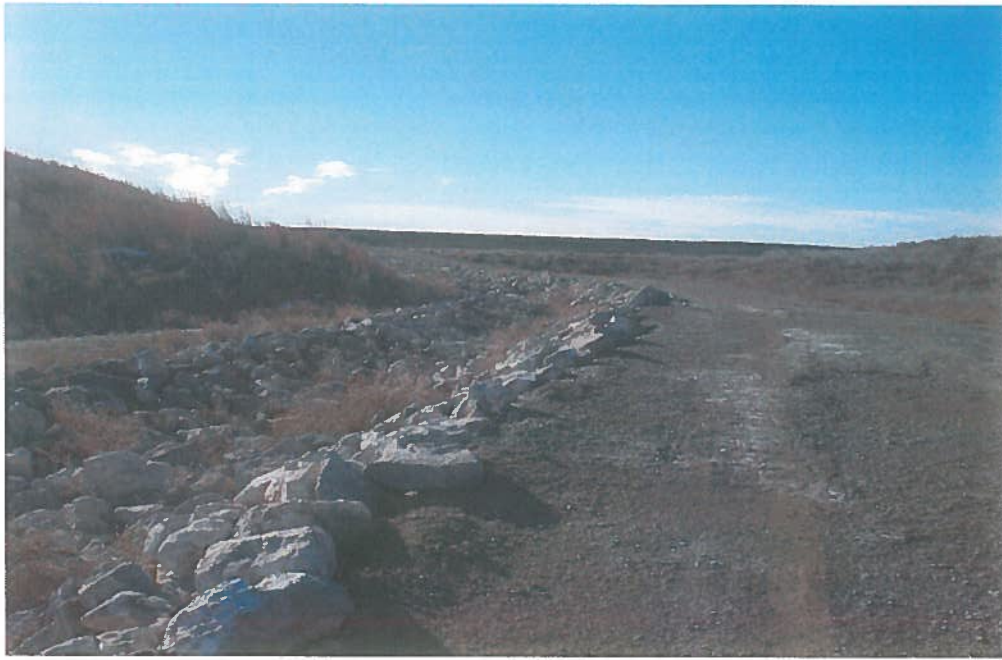
Photo 5: East end of contact water ditch for Landfill looking west

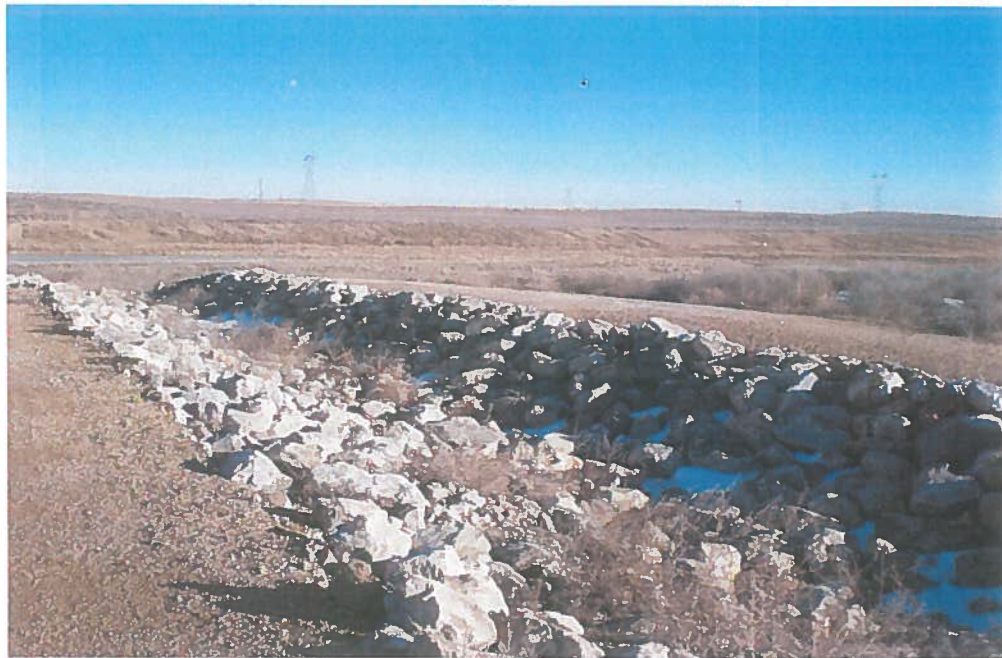
Photo 6: East end of contact water ditch to evaporation basin

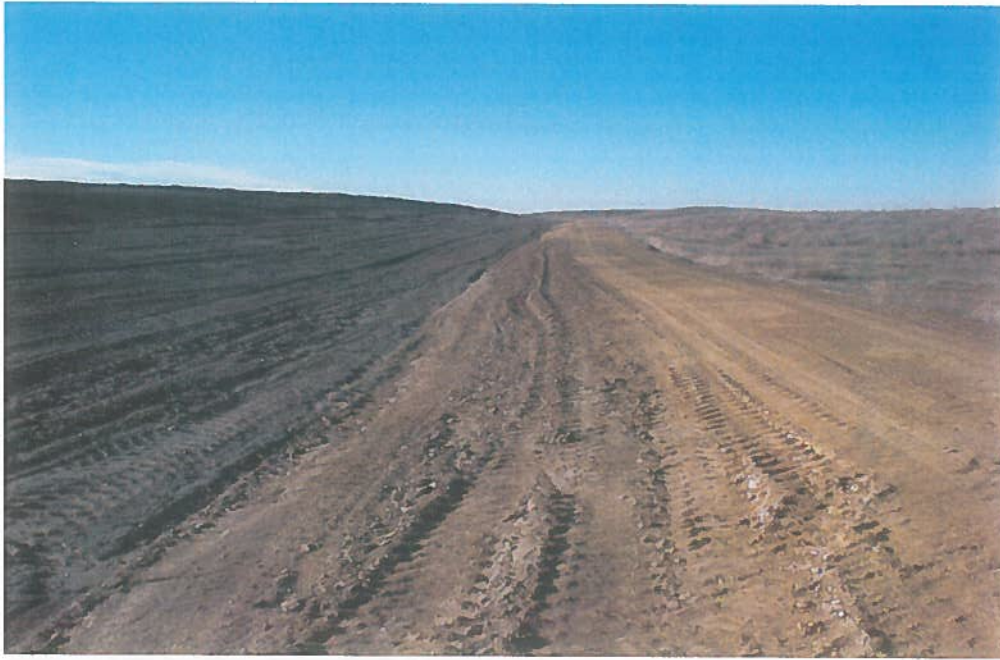
Photo 7: Access road around Phase 3A

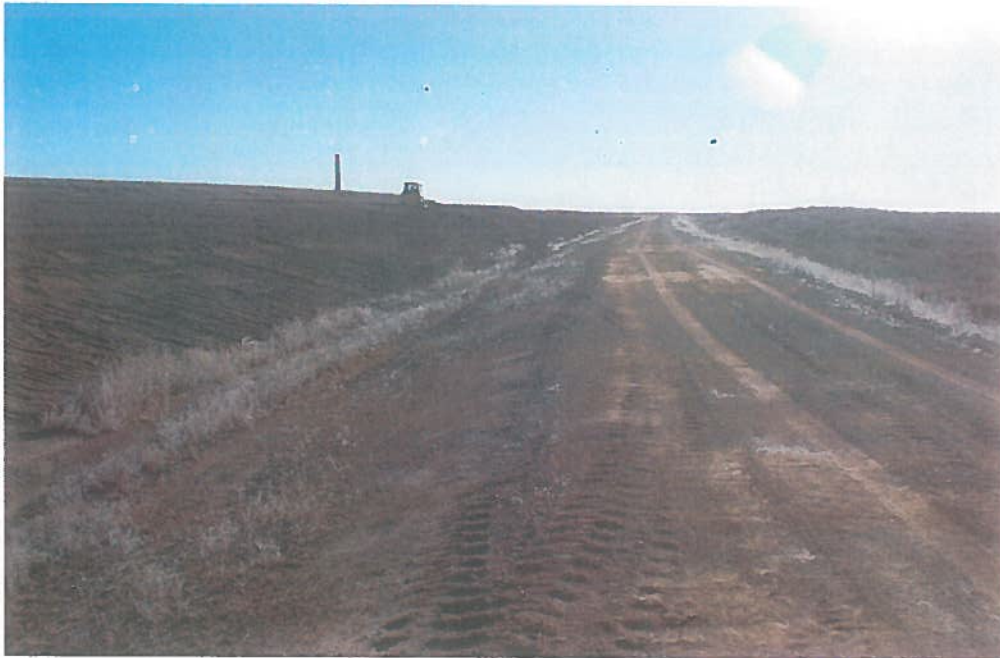
Photo 8: Looking south from access road around Phase 3A
